Hard landing, bounces, failure of nose landing gear

Aircraft	Saab 2000 registered HB-IZG
Date and time	28 January 2014 at 07 h 31 ⁽¹⁾
Operator	Darwin Airlines
Place	Paris Charles-de-Gaulle Airport (95)
Type of flight	Commercial air transport
Persons on board	Captain (PM) ⁽²⁾ , copilot (PF) ⁽³⁾ , 1 cabin crew, 16 passengers
Consequences and damage	Aeroplane severely damaged

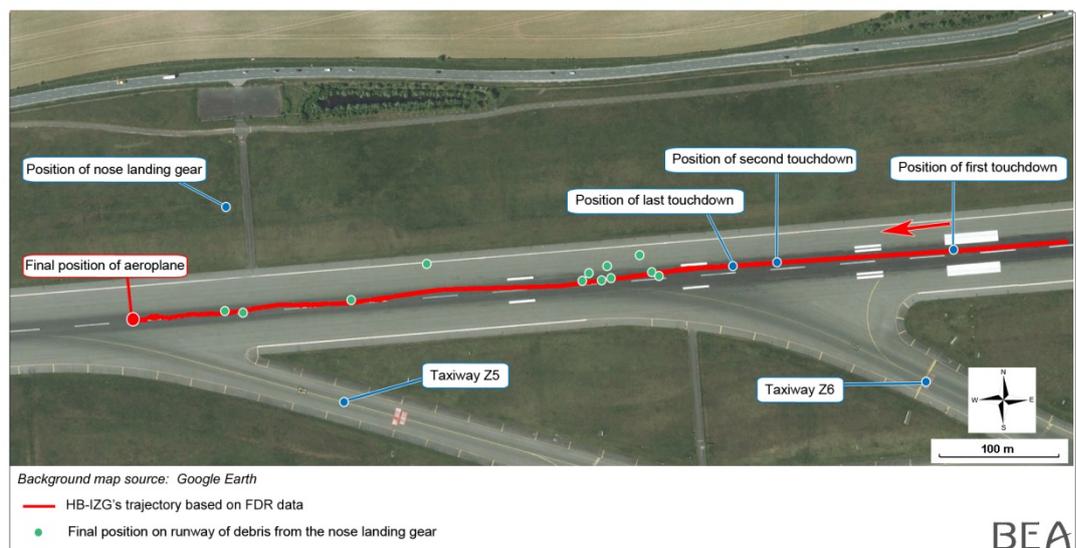
The aeroplane's nose landing gear hit the ground with a high vertical speed and broke off during the last touchdown. The aeroplane came to a stop on the runway.

Aeroplane flight path and map of parts found on the runway

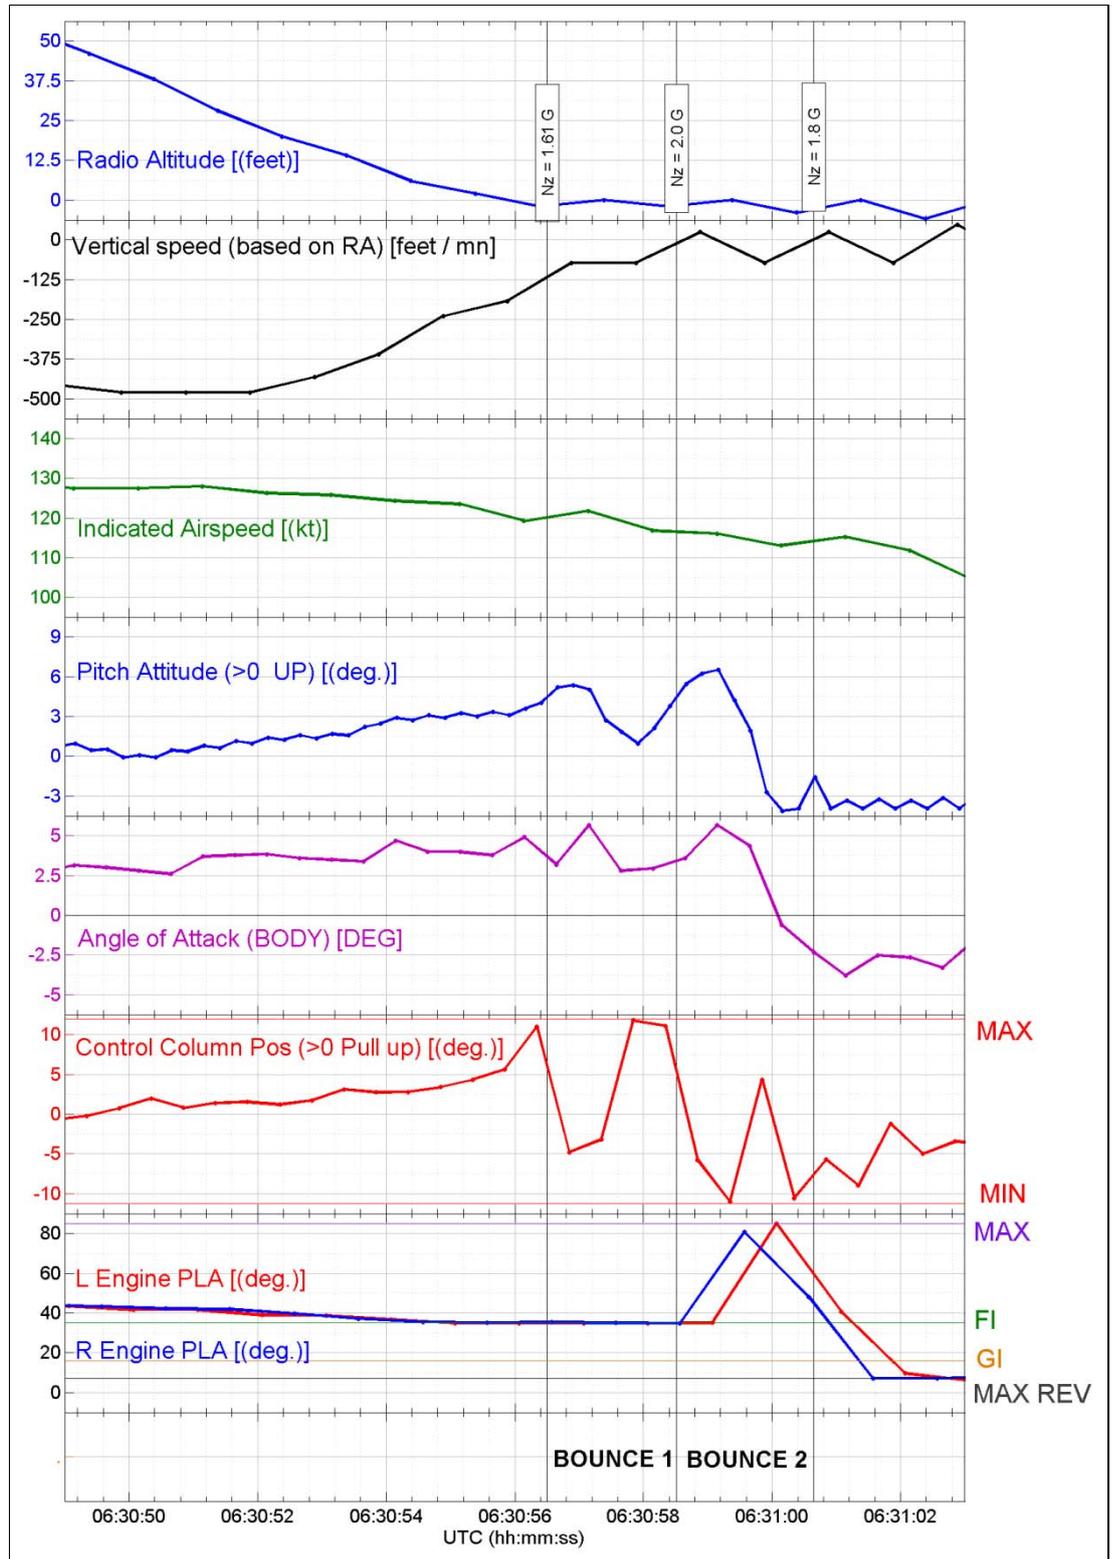
Analysis of the flight data made by the manufacturer based on the aeroplane model showed that the aeroplane touched the ground three times in the space of five seconds:

- 1st touchdown : only the two main landing gear units were in contact with the ground;
- 2nd touchdown : only the two main landing gear units were in contact with the ground;
- 3rd touchdown: only the nose landing gear was in contact with the ground. The failure occurred during this last touchdown. The vertical speed of the nose landing gear was estimated to be 11.5 ft/s.

Accident flight parameters during the landing
